**PERFORMANCE
OF
FLOODWATER RETARDING STRUCTURES
NEAR MCKINNEY, TEXAS
DURING
STORM OF SEPTEMBER 20 - 21, 1964**

Prepared by
U.S. DEPARTMENT OF AGRICULTURE
SOIL CONSERVATION SERVICE
Temple, Texas
August 1969

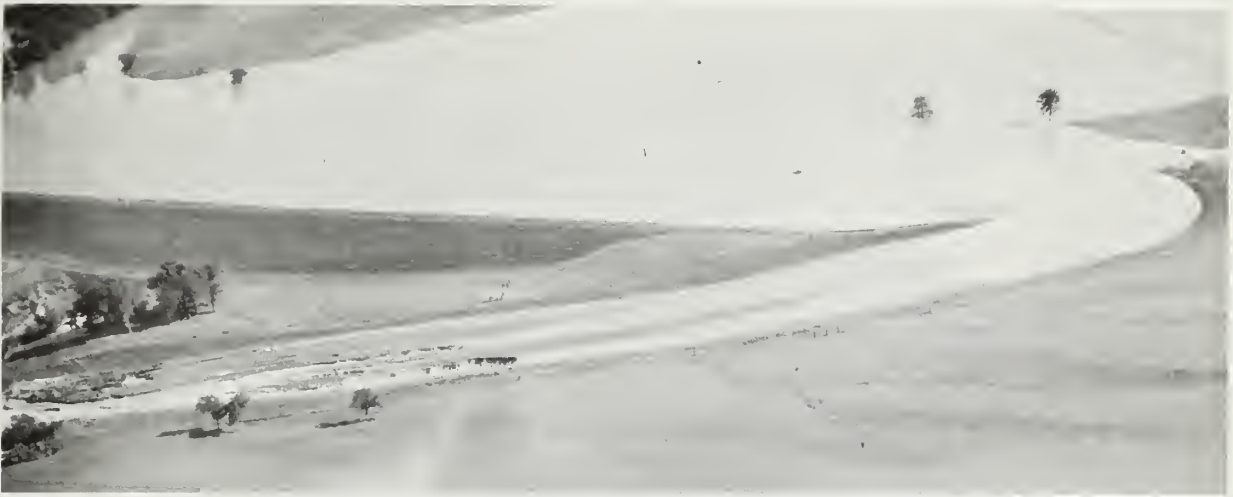
Structure 3B flowed about 3.3 feet deep in the emergency spillway. Scour damage occurred on the lower half of the emergency spillway exit channel.

It appears that damage to Structure 3B began in the area where natural seepage along the limestone outcrop kept the soil saturated. The saturated soils moved out and this started an overfall condition which progressed upstream. About 2500 cubic yards of soil was removed from the spillway.

Floodwater being detained behind Structure 3B, East Fork Above Lavon Watershed. Emergency spillway flow with damage at lower end after storm of September 20-21, 1964.

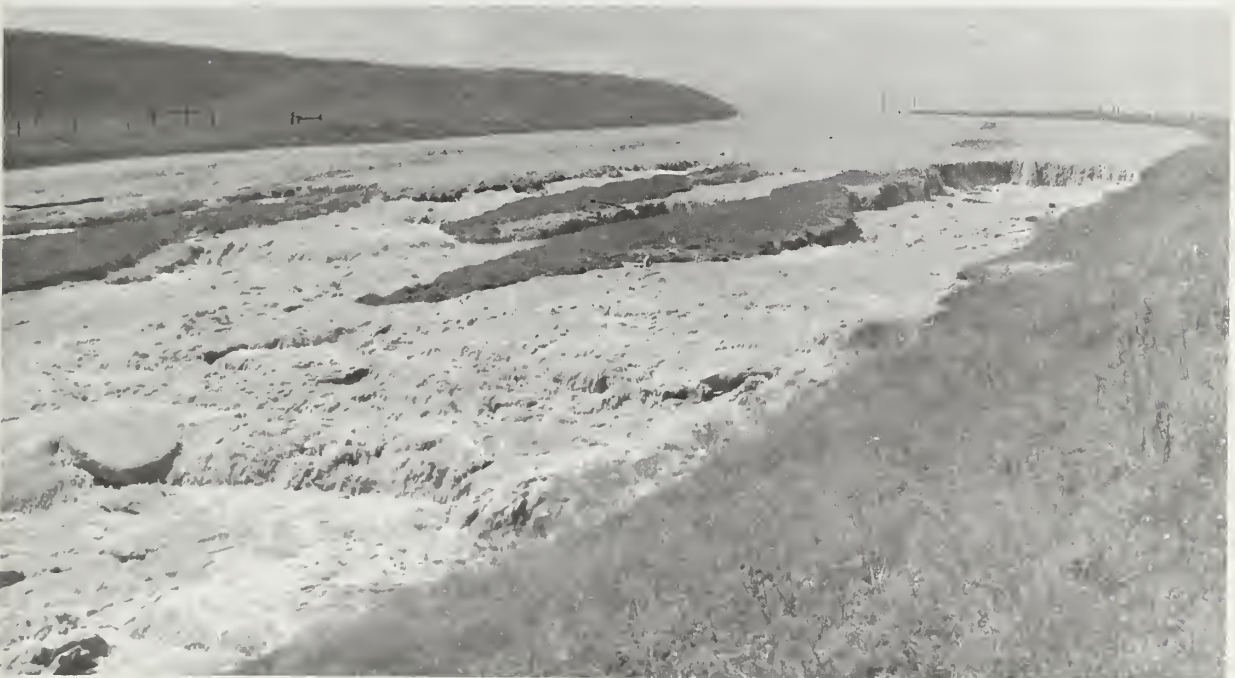
Emergency spillway on Structure 3B, East Fork Above Lavon Watershed, after the storm of September 20-21, 1964.

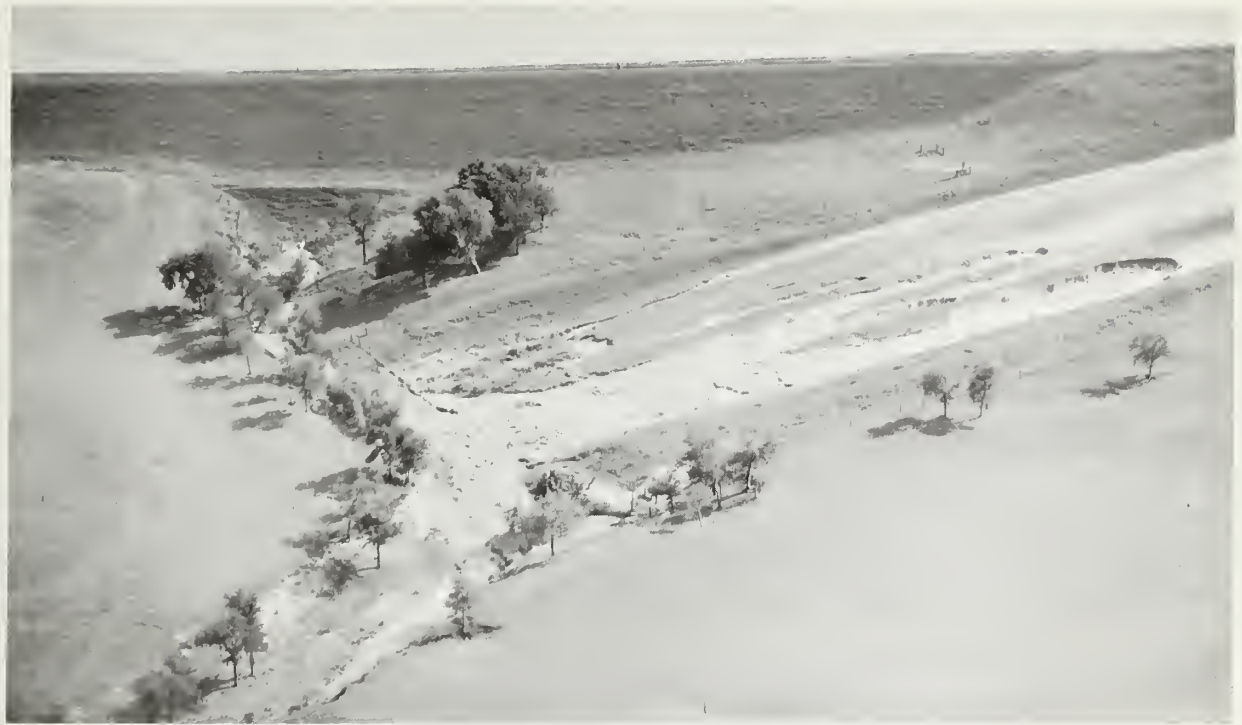
Emergency spillway on Structure 3B, East Fork Above Lavon Watershed, after the September 20-21, 1964 storm.

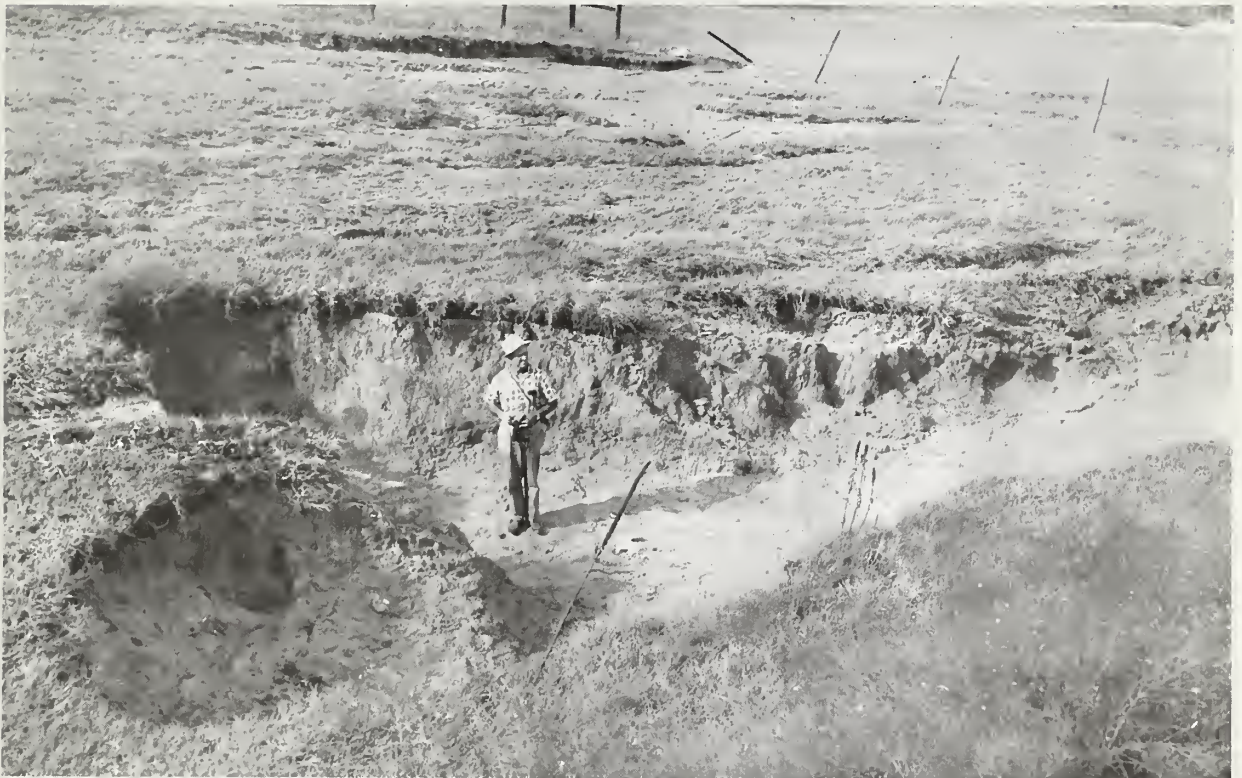
Damage to the emergency spillway of Structure 5A was limited to the removal of about 100 cubic yards of soil.

Emergency spillway on Structure 5A, East Fork Above Lavon Watershed, after the storm of September 20-21, 1964.

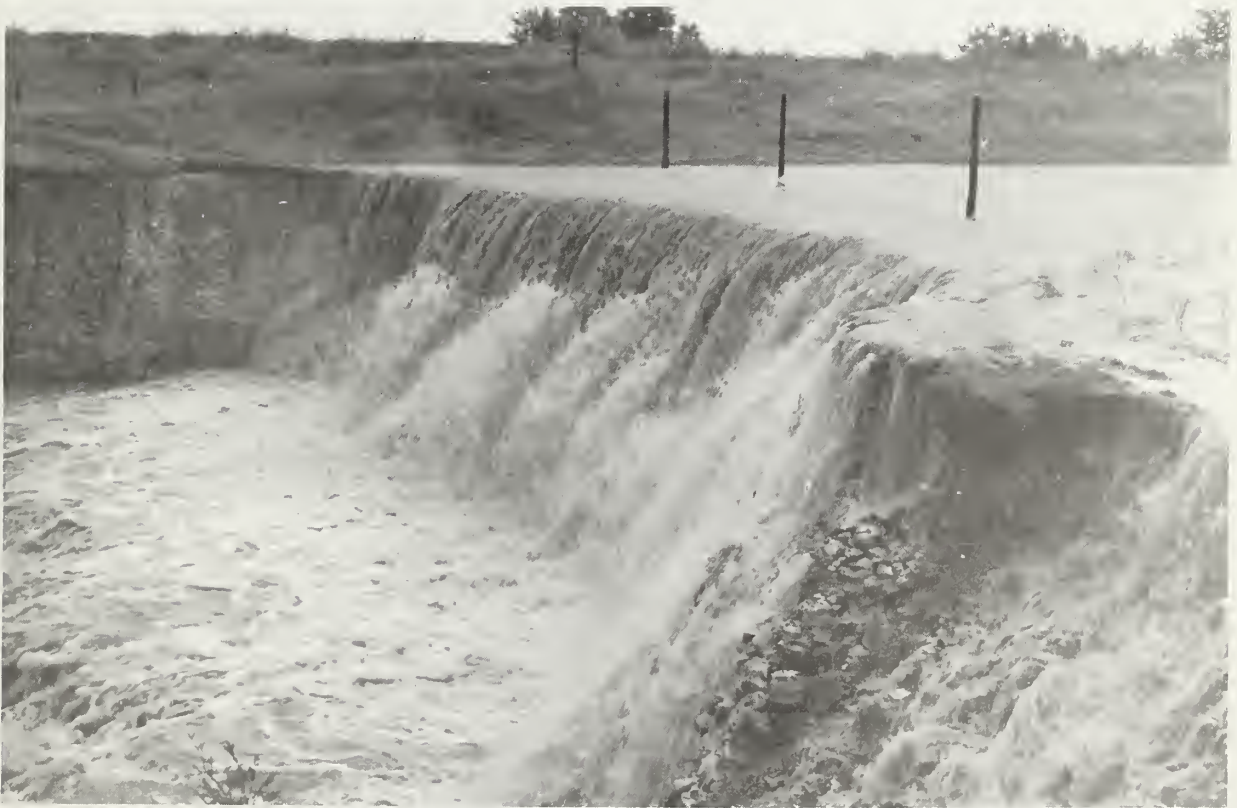
Structure 3C had slight damage to the emergency spillway. The fractured limestone overfall into the creek moved up the spillway exit channel approximately 20 feet. No repairs were needed.

Emergency spillway on Structure 3C, East Fork Above Lavon Watershed, after the storm of September 20-21, 1964.

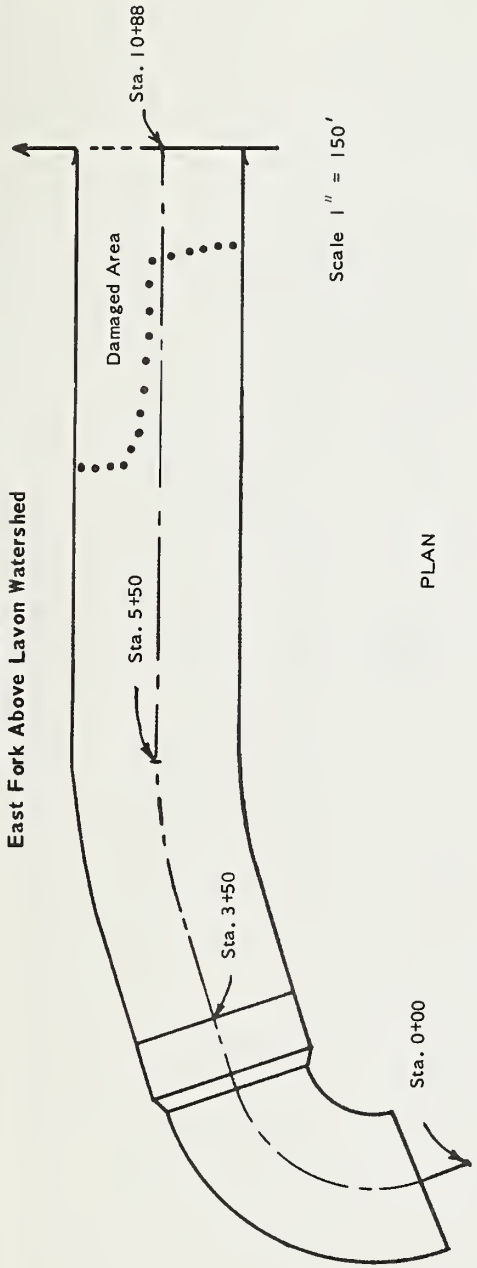
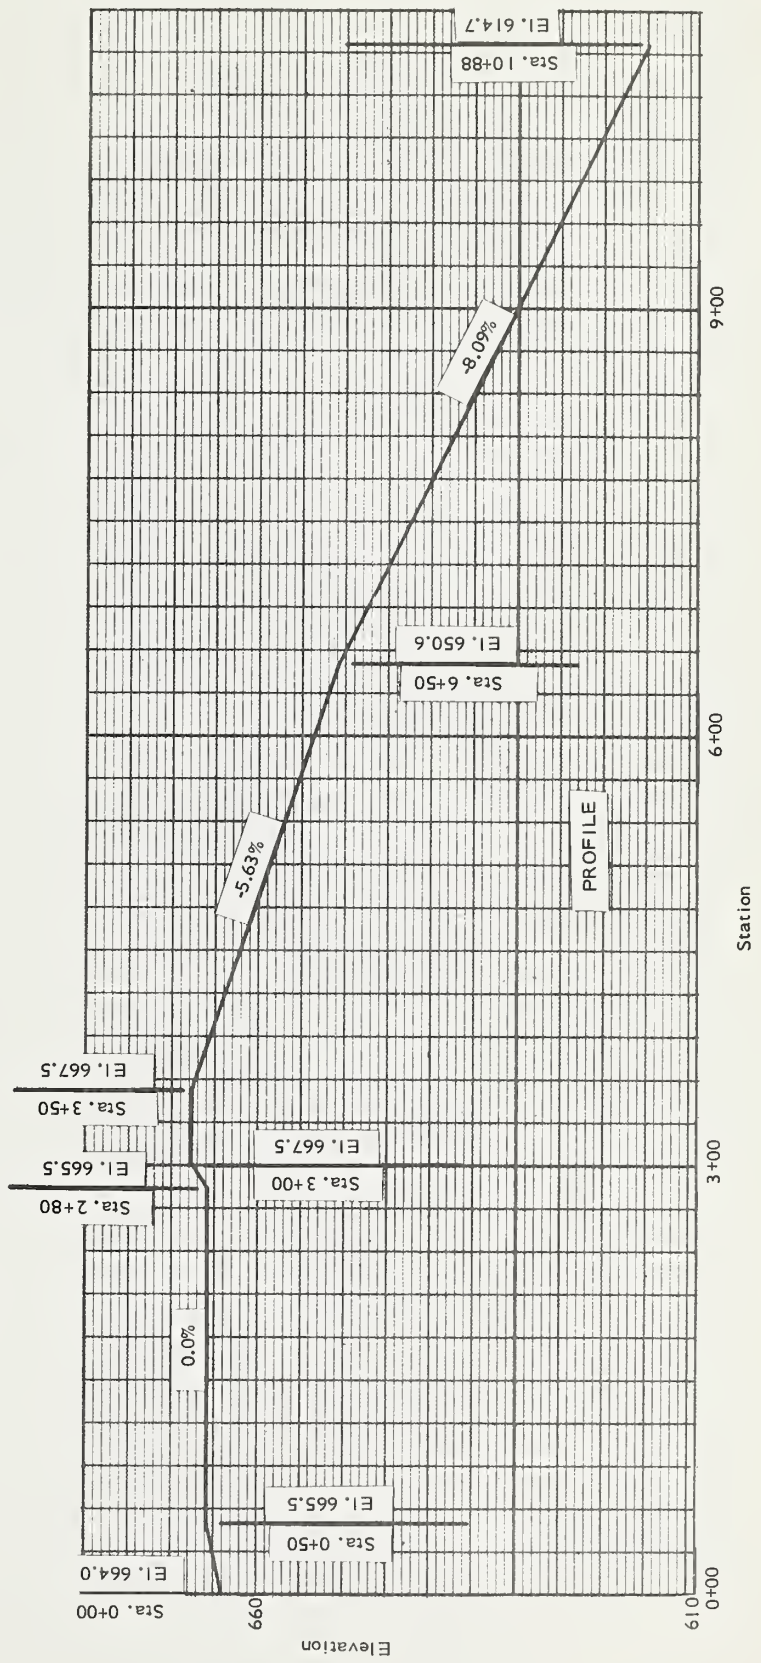
Figure 5A

Structure damages were limited to the emergency spillway exit channels. Figures 5A, 5B and 5C show the approximate area of the damage.
